# THE FLOW PROJECT

## SRH Water Technology, May and July 2022

Lobbbach in Haag
Date: 24.05.2022, 14.07.2022
GPS-Coordinate:
49°23'22.49"N 08°55'09.17"E

Ochsenbach in Schatthausen

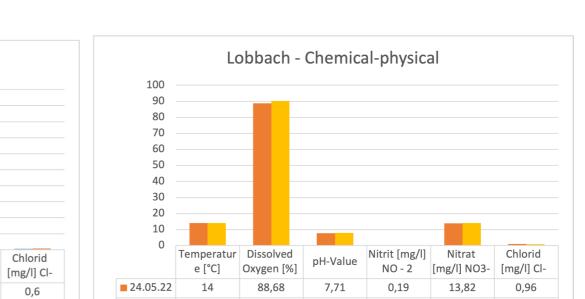
Similarly, all the substrate mapping found in Oschenbach and Lobbach is shown in the bar chart. Algae, wood and dead wood, living parts of terrestrial plants, sand, clay un d clay, stone, etc. were found. Looking at the spear, Oschenbach also received a poor score on pesticides of 0.24 and a TU of -0,52, while Lobbach received a good score on pesticides of 0.67 and a TU of -3,79. Details of the macrozoobethos can be found in the gr-code.

EQ pesticides

0.67 II: Good

- The SPEAR index for Ochesenbach was quality class 4 (poor), Lobbach was quality class 2 (good).
- The condition of the water body in Oschenbach was quality class 3 (moderate) in May and quality class 2 (good) in July. The condition of the Lobbach water body was quality class 2 (good) in both May and July.
- The Oschenbach is located near an agricultural environment. This could be the trigger for the elevated nutrient levels and pesticide contamination.
- Several macrozoobenthos species were found, some with high numbers of individuals. Apart from the pollutant and nutrient inputs, the Lobbach appears to be in good condition compared to the Oschenbach.
